SPACE SYSTEMS FAILURES

Disasters and Rescues of Satellites, Rockets and Space Probes

David M. Harland and Ralph D. Lorenz

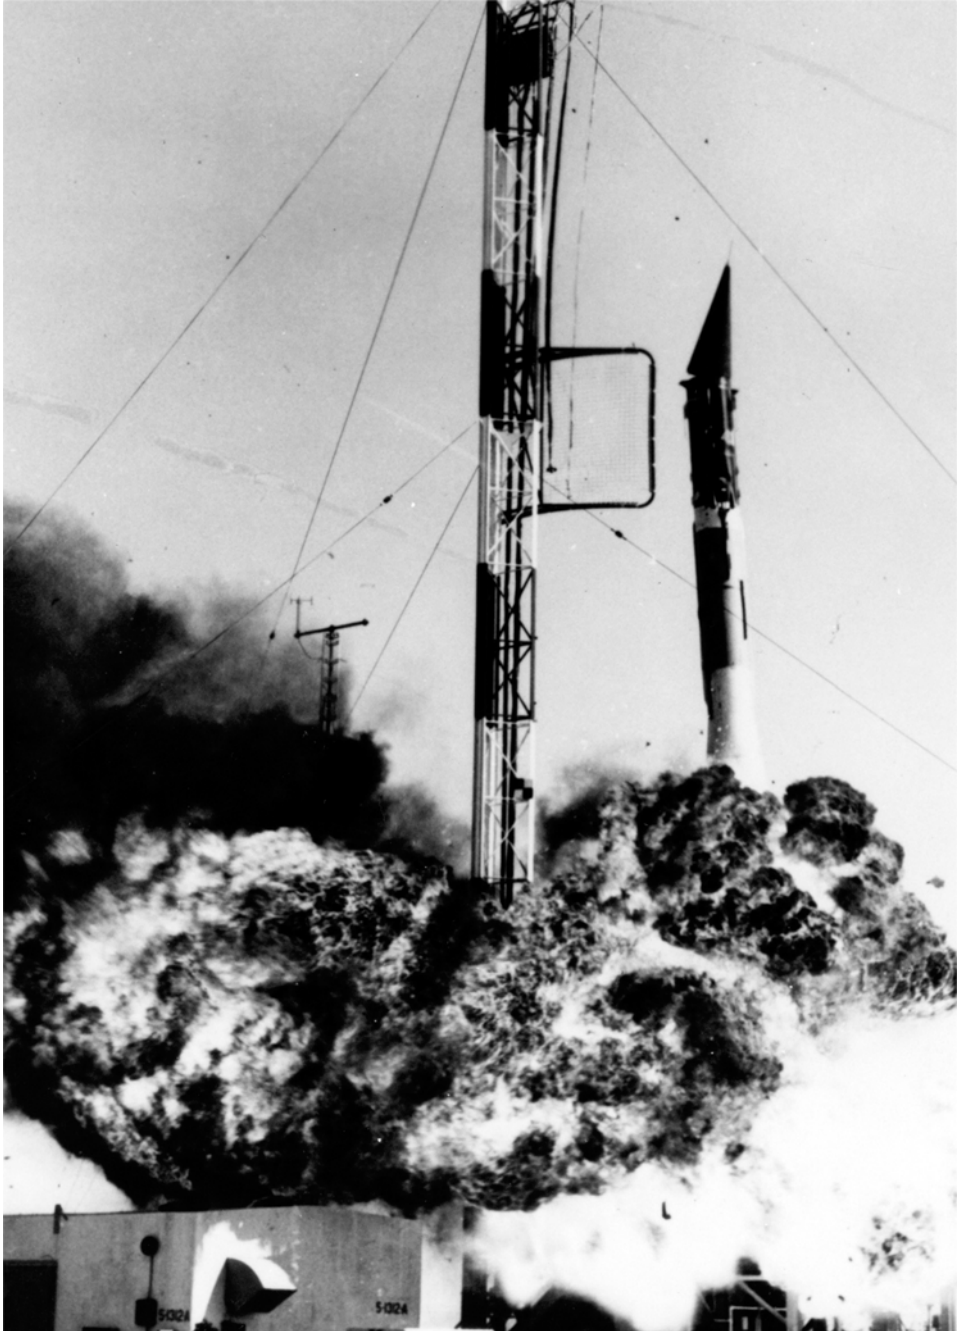
The attempt to launch Vanguard on 6 December 1957 failed when the vehicle lost thrust, toppled back onto the pad and exploded.

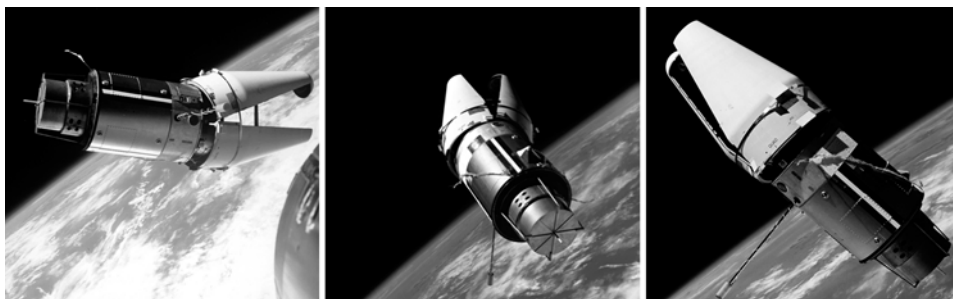
The ATDA with its fouled shroud.

side the vehicle, they found that the shroud had partially deployed – the pyrotechnics had separated its base from the vehicle and split it lengthwise, but a thin metal strap was preventing it from slipping off the aperture of the conical docking collar. Stafford likened the fouled shroud to the jaws of “an angry alligator”. When the pictures taken by the astronauts were examined by the engineers, the fault was identified. The Agena shrouds were made by Douglas Aircraft, and the Gemini–Agena Target Vehicles were built by Lockheed, whose pad technicians were trained to install the shrouds. However, the improvised Augmented Target Docking Adapter had been made by McDonnell (which had built the Gemini spacecraft and the docking system) and in this case the shroud had been fitted by McDonnell’s technicians, the Lockheed supervisor had been called away, and his verbal instructions for finishing the job had been misunderstood.

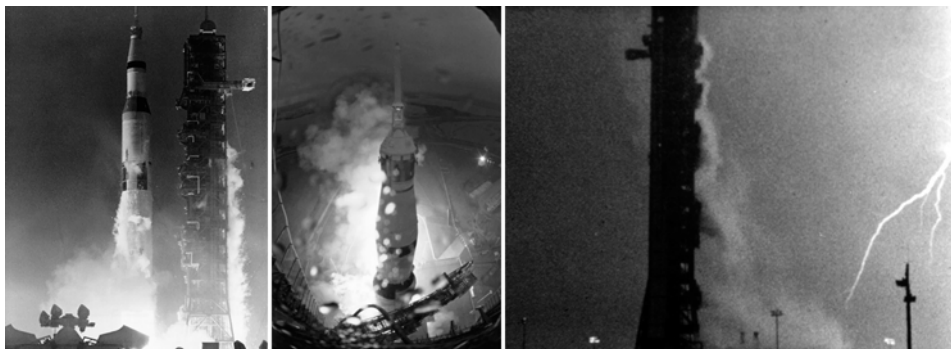
The launch of Apollo 12 into a thunderstorm, and the resultant lightning strike half a minute later.

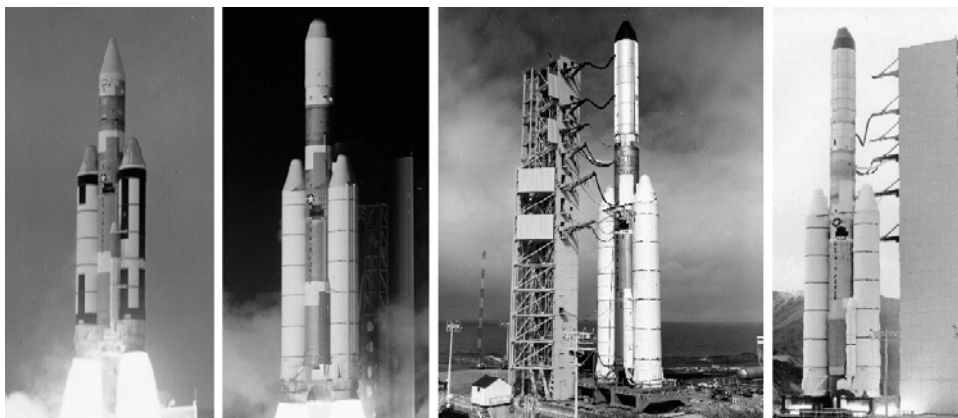
Titan IIIC and Titan IIID models (left to right): Titan IIIC, 18 January 1967 with a dispenser of eight satellites for the Initial Defense Communications Satellite Program; Titan IIIC, 14 December 1975 with the 5th IMEWS (the last of the first model of DSP); Titan IIID, 15 June 1971 with the 1st KH-9 'Big Bird'; Titan IIID, 14 June 1978 with the 2nd KH-11.

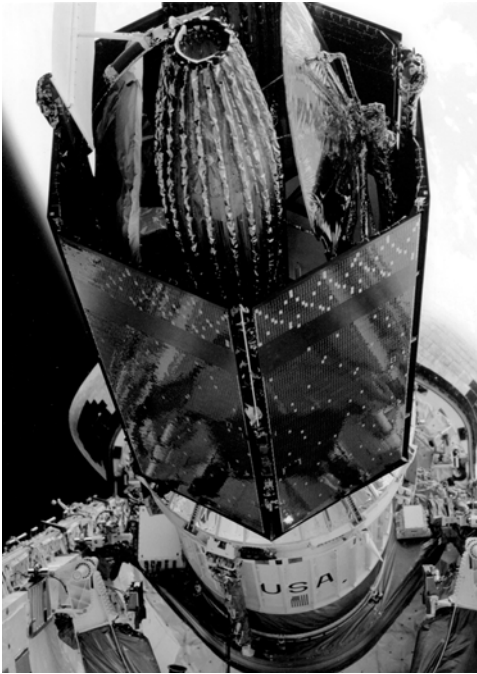
An IUS carrying a TDRS satellite elevated on its cradle.

Relay System. As this 2.2-tonne satellite was too heavy for a PAM, it used the more powerful IUS, and this 18-tonne stack was carried lengthwise, filling the bay. The first step in bringing the stack to life was to elevate the cradle to 30 degrees. The two-stage IUS was heavily instrumented and the control system of each of its stages was verified. By using a camera installed at the rear of the bay, the astronauts confirmed that the first stage's nozzle could gimbal. Once TDRS 1 was verified by the Air Force's satellite operations facility in Sunnyvale in California, the power umbilical was disconnected, and the elevation increased to 60 degrees. At the appointed time, the ring-clamp holding the IUS in place was unlocked to enable the spring to eject it. Ten minutes later (by which time Challenger had withdrawn) the IUS was activated. After a

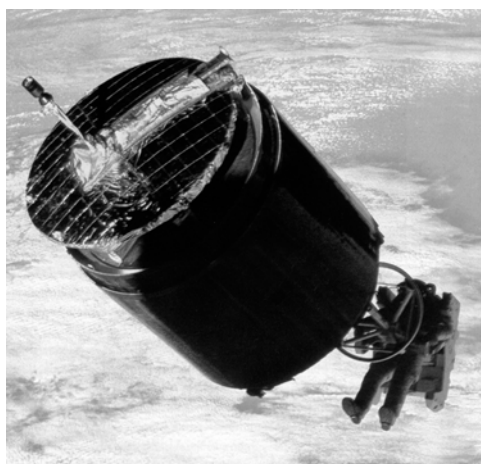
Dale Gardner manoeuvres to capture Westar 6.

to be turned upside down for stowage. A bracket had been built to run over the top of the drum, but this could not be attached. It had been tested on similar satellites at Hughes, but the model was tailored to its customer's requirements, and the feed horn of the folded antenna on top of this one projected a little further than the tool's designers had been told, preventing the clamps from engaging. In the original plan, Gardner was to affix the bracket, Fisher was to raise Allen back out of the bay and release him, Allen would flip the satellite to enable Fisher to grip the trunnion pin on the bridge that Gardner had fitted, Allen would disengage the stinger, and Fisher would line up the satellite and lower it onto the waiting mount. Given that the common bracket clamp (as the bridging bracket was formally known) would not fit, the astronauts set out to improvise. In the revised plan, Allen disengaged, leaving the arm grasping the satellite via the stinger. While Allen stowed the MMU, Gardner placed a portable foot restraint on the sidewall. Allen then stood on this restraint and took hold of the satellite by its still-folded main antenna. When Fisher withdrew the arm, Allen did his best to hold the satellite steady while Gardner disengaged the stinger. Gardner placed a 'shower cap' over the motor nozzle to prevent flakes of solid propellant falling out into the bay when Discovery landed. Gardner then disconnected the A-frame carriage mount from the bay floor and mated it to the ring on the base of the satellite. Throughout this activity (which lasted well over an hour) Allen held the satellite steady. With the mount attached, they pitched Palapa down into the bay and Gardner reconnected the A-frame to the bay floor. In all, the retrieval had taken six hours.

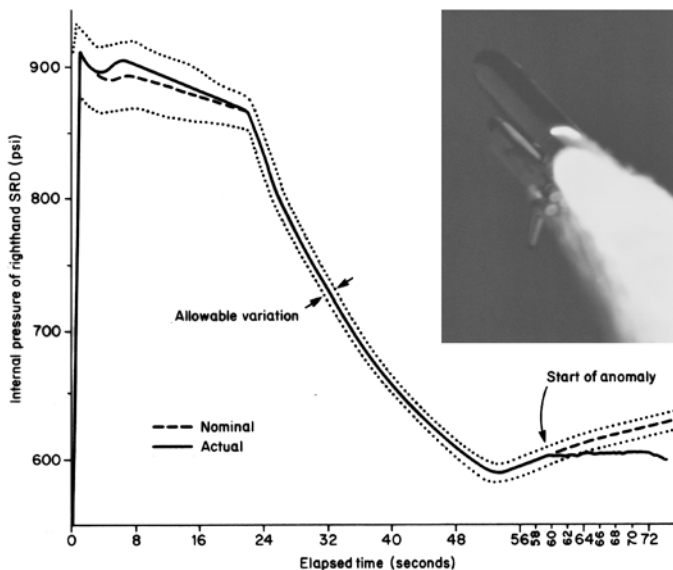
A plot of the pressure in the righthand SRB of STS-51L, and (inset) the plume that spewed from the field joint that was responsible for the anomaly.

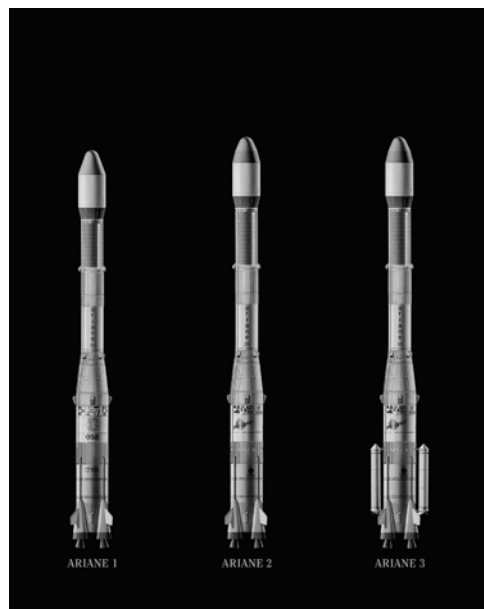
The Ariane 1, 2 and 3 configurations.

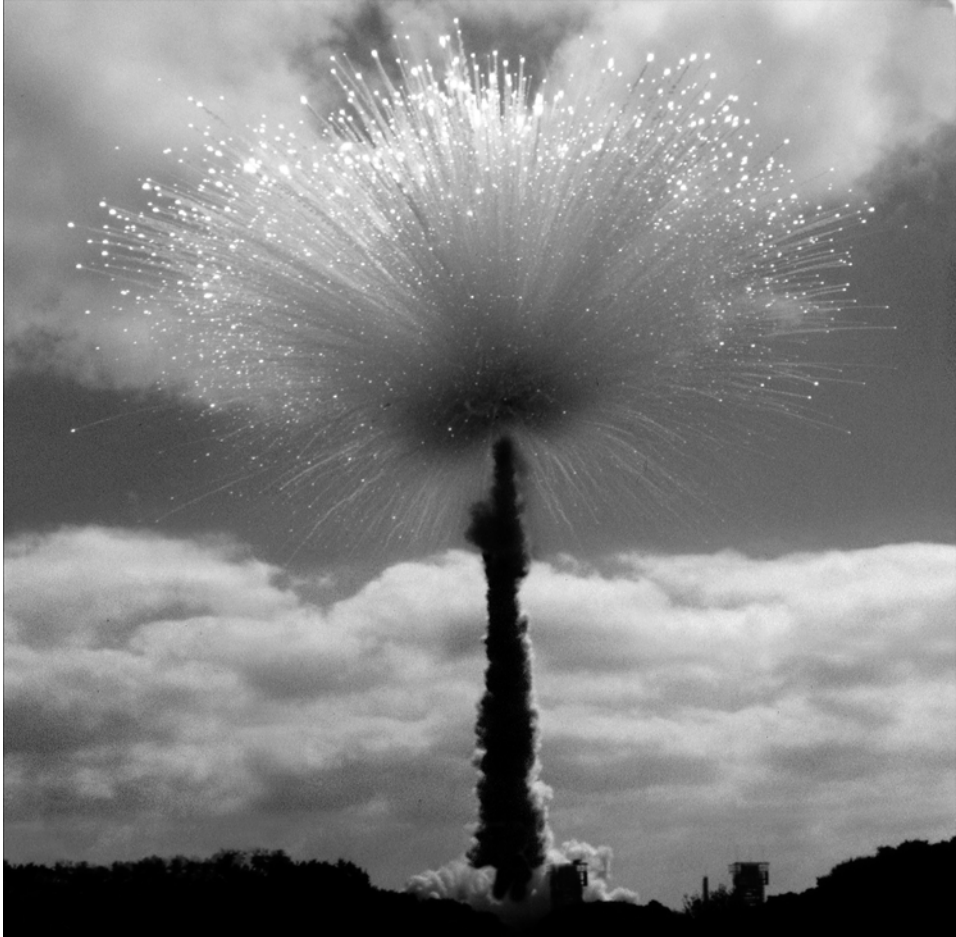
The explosion of the Delta II on 17 January 1997 carrying the 1st Block-IIR NAVSTAR satellite.

A series of photographs by Carleton Bailie for *Aviation Week & Space Technology* showed black smoke venting from the side of one of the solid strap-ons about six

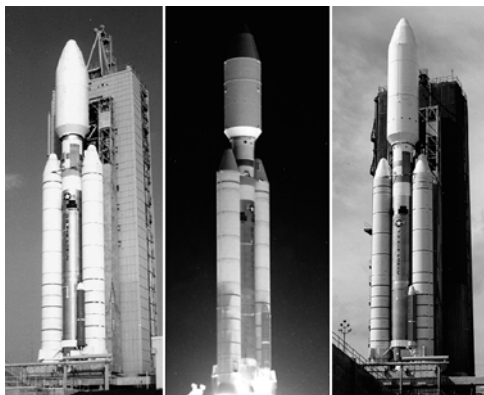
Titan IVA models (left to right): Titan IVA–IUS, the 1st vehicle of this type, which was launched on 14 June 1989 with a DSP satellite; Titan IVA on 8 June 1990 with four satellites for the Naval Ocean Surveillance System; Titan IVA–Centaur awaits launch on 7 February 1994 with the Milstar DFS 1 satellite.

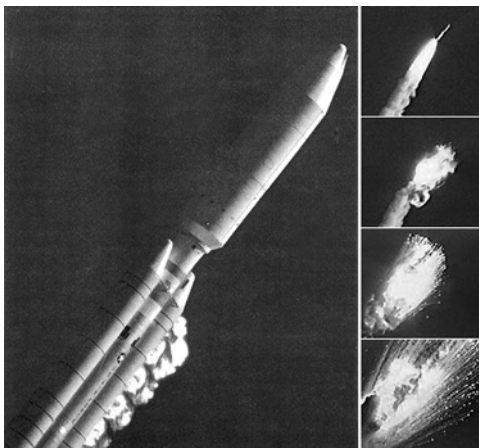
The destruction of the Titan IVA–Centaur at T + 41 seconds on 12 August 1998.

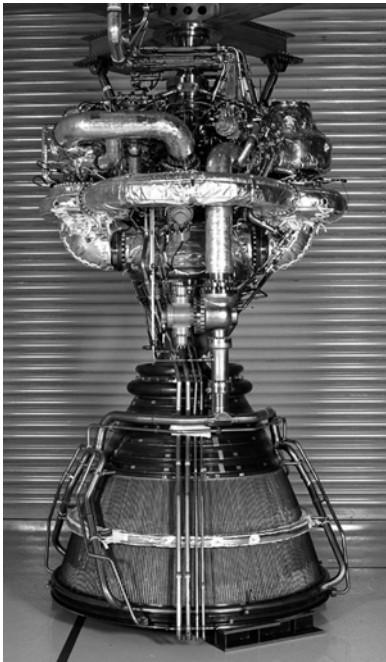
The LE-7A engine of the H-2A.

Since the H-2 had suffered a number of failures for *different* reasons, the final mission in 2000 was cancelled and its payload reassigned to the H-2A. However, because the development of the LE-7A engine was proving more difficult than expected, the first launch of the H-2A was slipped to early 2001.^{190,191,192,193}

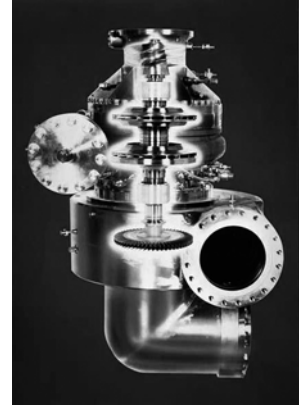
The liquid hydrogen turbopump of an LE-7 engine.

plumbing running between the hydrogen pre-burner and the turbopump, or a failure of the turbopump. In January 2000 an underwater imaging probe operated by the Japanese Marine Science and Technology Centre located the wreckage of the first stage on the sea floor at a depth of almost 3 kilometres. The 12-tonne LE-7 engine was raised and sent to the National Aerospace Laboratory in Tokyo, where it was confirmed that it had been starved of hydrogen, and the cause came as a shock.^{182,183,184} An 8-inch blade in a 3-bladed inducer, which spun at 42,000 revolutions per minute to feed liquid hydrogen into the turbopump, was broken.¹⁸⁵ This was not a manufacturing problem; it was a fatigue fracture resulting from repeated exposure to excessive force. When a bladed-wheel rotates in a liquid, the pressure decrease near the blades can generate bubbles of gas. In this case, as the blades and bubbles swept round at different speeds, pressure fluctuations on the blades as they hit the bubbles caused a resonance that resulted in fatigue failure. This

phenomenon of 'rotating cavitation' had been observed during the development of the LE-7, and although it had been considered that the blades were strong enough to resist it, this had proved to be false.¹⁸⁶ The vibrations also cracked a weld in the inlet to the turbopump, and caused the engine to be starved of fuel. The lost payload was the 1,600-kilogram Multi-function Transport Satellite (MTSAT 1) that had been built by Space Systems/Loral for the Japanese Ministry of Transport to supplement air traffic control communications in the Asia Pacific region. The replacement (MTSAT 1R) was not shipped to Japan until March 2004 for launch in early 2005.^{187,188,189} Unfortunately for Japan, Hughes exercised a clause in its contract that allowed for a painless cancellation in the event of two consecutive failures of the H-2.

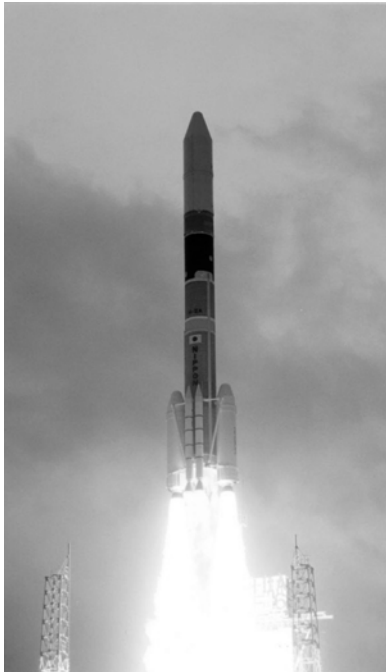
The 6th H-2A lifts off on 29 November 2003.

On 29 November 2003, one of the two Nissan strap-ons on the sixth H-2A suffered a nozzle burn-through which disabled the pyrotechnic package that was to have jettisoned it.^{209,210,211} By T+11 minutes, the ‘dead weight’ of this appendage had caused the vehicle to veer so far off course that the second stage would not be able to recover the trajectory. It was therefore destroyed.²¹² The second pair of Information Gathering Satellites were to have augmented the first pair (launched by the previous H-2A on 28 March) for a scheduled constellation of eight satellites intended to enable Japan to monitor North Korean missile tests. (The programme was in trouble anyway, because the performance of the satellites was reportedly disappointing.)

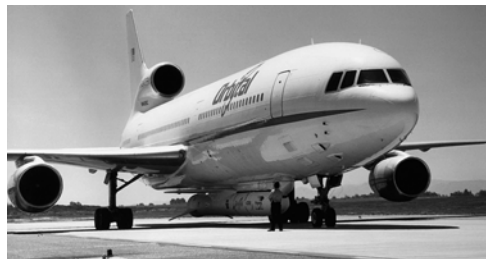
The L-1011 'Stargazer' with a Pegasus mounted on its belly.

OSC's more powerful Pegasus XL was longer than the original, to accommodate 24 per cent more propellant in the first stage and 30 per cent in the second stage. The third stage was unchanged. The 60 per cent overall increase in performance was to enable it to insert 340 kilograms into a circular orbit at an altitude of 740 kilometres. Its introduction on 27 June 1994 also marked the first use of the Lockheed L-1011 Tristar, 'Stargazer', which had been bought from Air Canada and modified to carry the rocket on its belly.¹⁶ In fact, the B-52 could not carry the stretched form of the launch vehi-

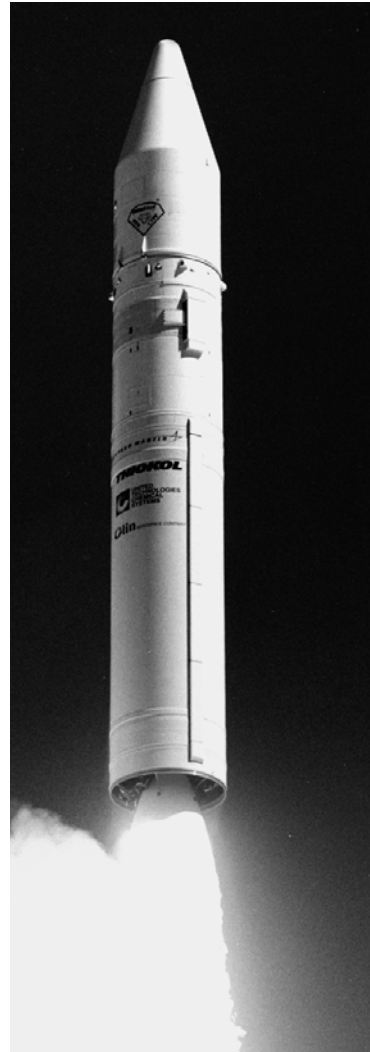
The inaugural launch of the Athena I on 15 August 1995.

As the Athena I lifted off for its inaugural launch on 15 August 1995 from SLC-6 at Vandenberg, looking diminutive among the pad facilities built for much larger rockets, the programme was some nine months behind schedule.⁵³ The vehicle was carrying the 150-kilogram GEMstar data-relay satellite for CTA Space Systems. It was to put the satellite into a polar orbit at an altitude of 680 kilometres, but at T+160 seconds it veered off course and the range safety officer destroyed it some 466 kilometres downrange, at an altitude of 148 kilometres.^{54,55} The tracking camera footage indicated that an anomalous pitch excursion started at T+79 seconds. The investigation focused on the 500 telemetry channels from T+65 seconds to the shutdown of the first stage at T+82 seconds. After the first stage had been jettisoned, the vehicle coasted (as planned) until the second stage ignited at T+150 seconds, but at T+121 seconds the ‘coning’ motion it had

inherited dislodged the shroud 24 seconds before it was to have been shed. Although the second stage rapidly stabilised itself, the range safety officer destroyed it because it was not on the desired trajectory.^{56,57} In fact, *two* independent failures were found, either of which would have led to the loss of the vehicle.⁵⁸ The thrust-vectoring system had induced the attitude excursion shortly prior to first stage shutdown. The inertial measurement unit had failed while coasting, at T + 127 seconds. The Castor 120 was a modified missile booster with a carbon–epoxy casing and a ‘submerged’ flexible nozzle bearing that was driven through 5.5 degrees of deflection by cold-gas-pressurised hydraulic actuators to vector the thrust to steer the vehicle. The spent hydraulic fluid was vented, but it caused a fire that eroded the insulation of the cable with the signal from the sensors that measured the orientation of the nozzle, causing a short circuit that made the control system deflect the nozzle – which induced the attitude excursion. The thrust-vectoring system was similar to that of the Peacekeeper, except that the hydraulic fluid in that case had not been vented. The solution was to install a reservoir to collect the spent hydraulic fluid, thereby forming a closed system. The subsequent inertial measurement unit fault resulted from corona arcing in its power supply. Litton, the manufacturer, had tested the unsealed package for this phenomenon, but only to the 70,000-foot limit of its vacuum chamber. A test by Lockheed Martin for the investigation established that it began to arc at 86,000 feet! The solution was to apply a compound to protect the components that were susceptible to arcing, and to seal the package. It was an object lesson in favour of high-fidelity testing. The Castor 120 had been adopted for several other ‘lightweight’ launch vehicles, but this was its first flight. In light of this failure, the development of the Athena III was put on hold.⁵⁹ Despite this setback, Lockheed Martin was confident that in June and July 1996 it would be able to launch the Lewis and Clark satellites that NASA had initially booked with OSC’s Pegasus and later reassigned to the Athena, but this optimism was to prove unfounded.^{60,61,62} After two years of redevelopment, it was hoped to launch an Athena I in May 1997, but this was slipped to provide more time to analyse a test of the revised thrust-vectoring system.⁶³ An Athena I from Vandenberg finally placed Lewis into orbit on 22 August 1997, but the satellite immediately malfunctioned, leading NASA initially to postpone and later to cancel the second satellite.

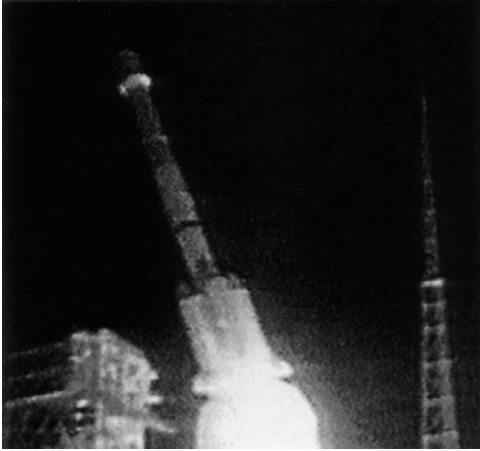
A Long March 3B topples over within seconds of lifting off on 14 February 1996.

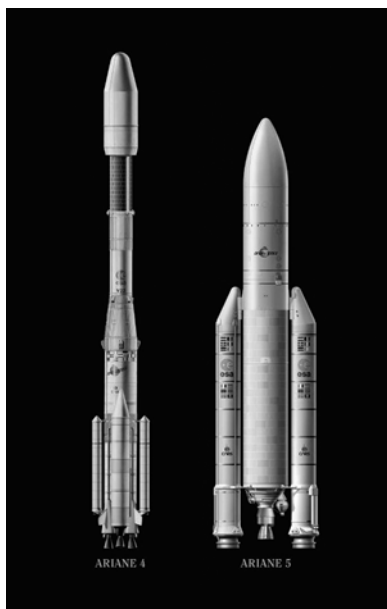
A comparison of the configurations of the Ariane 4 and Ariane V.

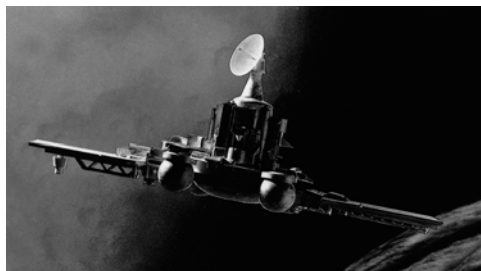
An artist's impression of the Phobos 2 spacecraft manoeuvring in close proximity to Mars's primary moon.

imposes complexity. A notable failure of this kind of arrangement was that of Phobos 2. This spacecraft was launched by the Soviet Union in 1988 with computers that proved to be faulty. One processor expired *en route* and another began to malfunction intermittently soon after the spacecraft entered orbit around Mars.⁴ Unfortunately, the voting logic was not itself reprogrammable, and with two failed units voting ‘no’ the sole functioning processor was unable to make its ‘yes’ vote heard! On 27 March 1989, as the spacecraft was manoeuvring in the vicinity of the eponymous Martian moon, it failed to commence a planned downlink. Some fragmental signals were subsequently received which indicated that the supposedly 3-axis stabilised spacecraft was spinning in a state of uncontrolled precession, and beyond recovery. In one sense, the proximate cause was component failure but the inflexibility of the voting logic contributed to the loss of the spacecraft by permitting correlated failures to accumulate. Of course, the third processor may well have failed long before the spacecraft was able to complete its mission.

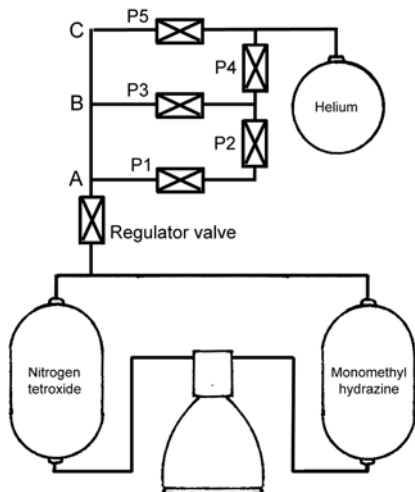
A schematic of the pressurisation section and valve ladder of the main propulsion system of a Viking orbiter.

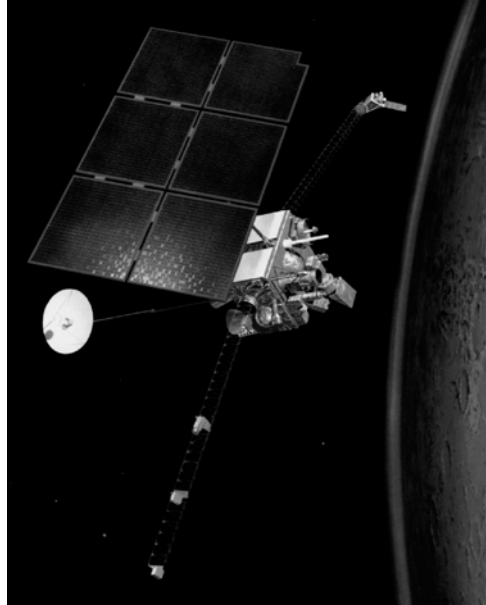
An artist's depiction of the Mars Observer spacecraft in its operational configuration in orbit around Mars.

Space). The first mission, Mars Observer, was launched on 25 September 1992 by the final Commercial Titan. It was to conduct a global survey of the Martian surface and atmosphere over the course of a local year of 687 terrestrial days to produce a composite global portrait to match the unprecedented perspective of the Earth gained from satellites such as Landsat. The 2.5-tonne, 3-axis stabilised spacecraft was to control its orientation using four reaction wheels, deriving attitude information from a horizon sensor (defining the nadir), a star mapper (for inertial attitude), gyroscopes and accelerometers (for angular rates and linear accelerations), and a suite of Sun sensors. The X-Band communications system used a 1.5-metre-diameter articulated high-gain antenna on a 6-metre-long boom. In Sun-synchronous orbit around Mars,

a six-segment solar array with a total area of 24 square metres was to be unfolded to generate between 1.1 and 1.5 kilowatts. It had hydrazine and bipropellant propulsion systems for interplanetary trajectory manoeuvres, initial Mars orbit insertion and circularisation, and subsequent orbit maintenance.⁶

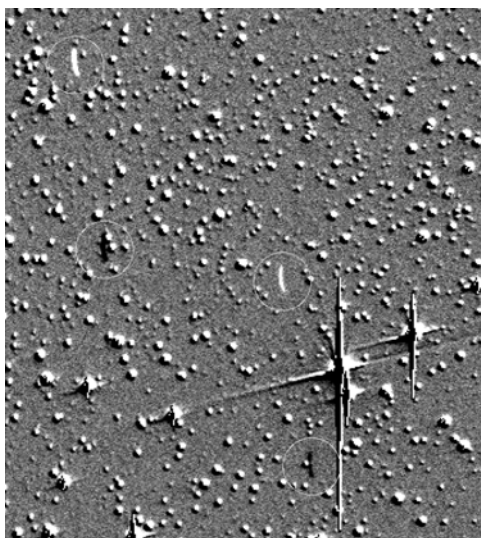
Spacewatch imagery captured trails of what could only be fragments of the CONTOUR spacecraft.

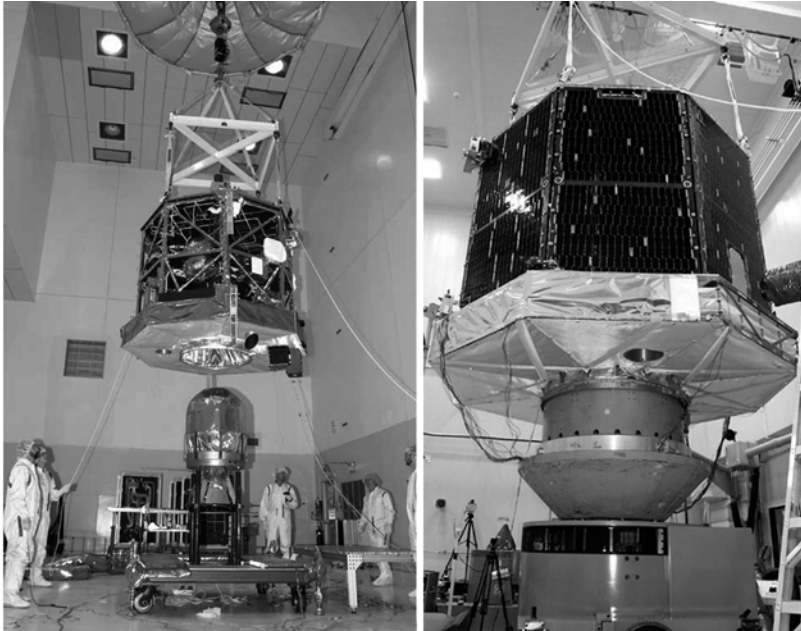
The CONTOUR spacecraft being mated with its solid rocket motor, showing that it was deeply embedded in the structure.

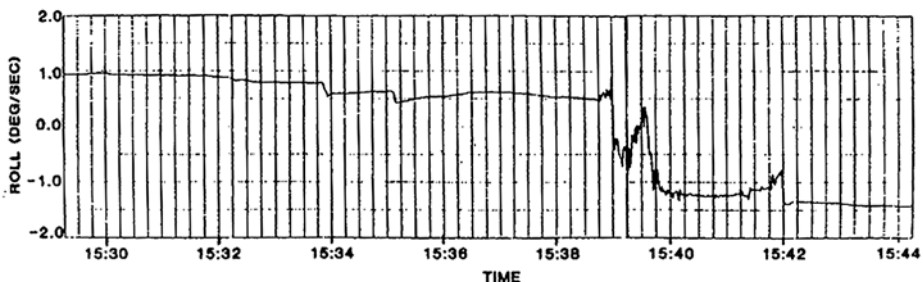
A plot showing how an astronaut's efforts at capturing SolarMax perturbed the satellite. ('The dynamics of the Solar Maximum Mission spacecraft capture and redeployment on STS-41C', K.J. Grady at the Guidance and Control Conference in 1985)

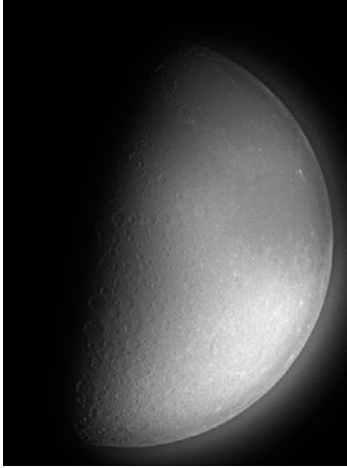
A 'foggy' image of the Moon taken by the Stardust spacecraft.

January 2004, catch some cometary dust in aerogel, and return this to Earth in early 2005 in a capsule. On the interplanetary cruise, scientists became concerned when a blurring fog developed on the camera in late 2000 as a result of an unidentified oily substance contaminating its main mirror. Pictures taken of the Moon from a range of 100,000 kilometres shortly after the Earth flyby on 15 January 2001 confirmed this. Activating the heaters to warm the optics from -35°C to $+8^{\circ}\text{C}$ had removed the fog by the end of the year,¹²² but it had reappeared by next March and the decontamination procedure had to be repeated. Long-range images taken of asteroid 5335 Annefrank on 2 November 2002 were excellent, as were those from the comet encounter.

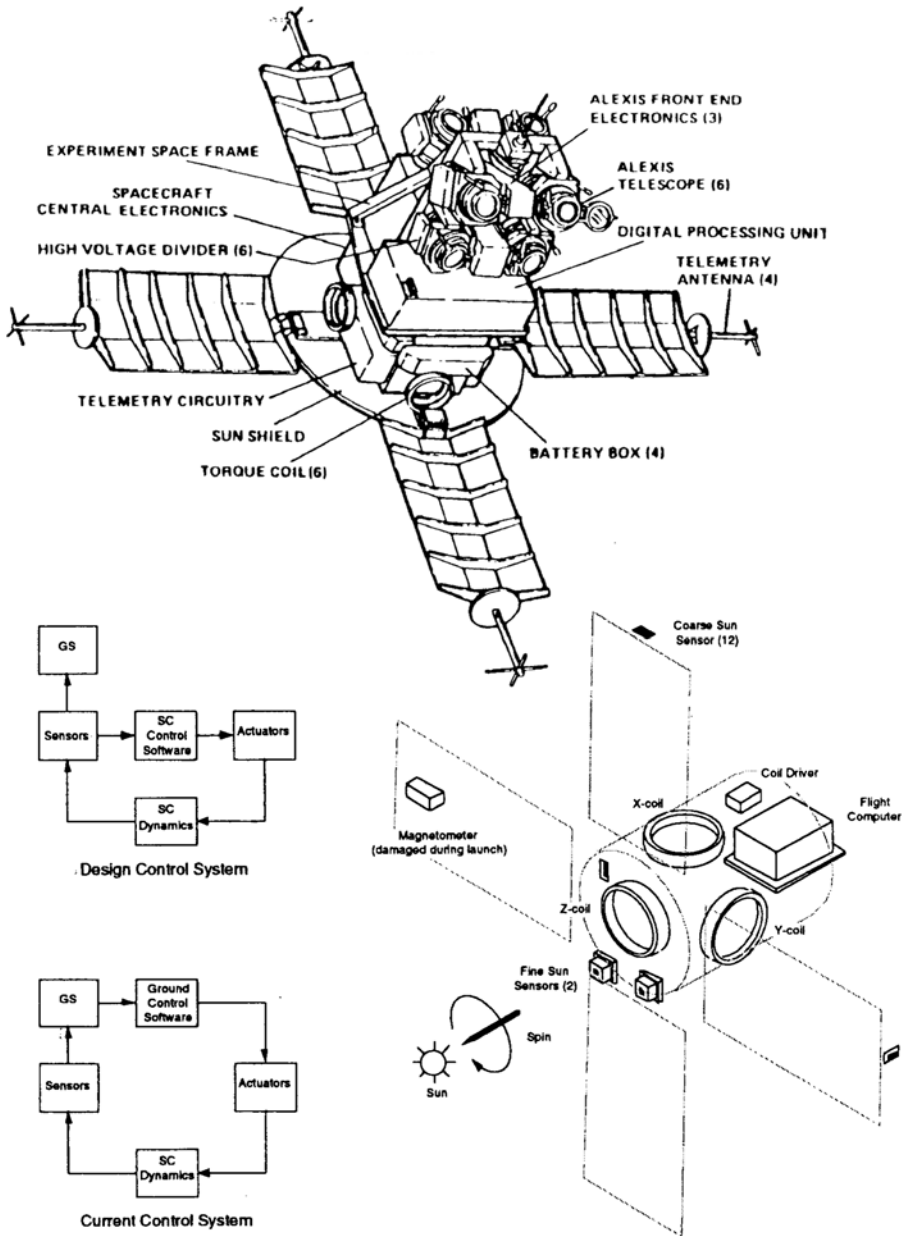
The Alexis satellite in the intended orbital configuration (top) in which it would spin on its axis at about 2 revolutions per minute, with the cells on the underside of its panels (as shown) facing the Sun. The major elements of the attitude control system (right). Block diagrams (left) of the attitude control system as designed, and as modified in use to cope with the loss of the magnetometer. ('The Alexis mission recovery', J. Bloch *et al.*, AAS-94-062.)

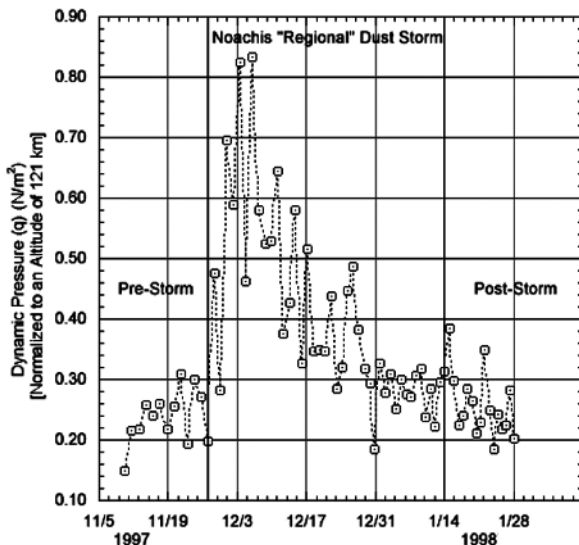
A plot of the dynamic pressure encountered by Mars Global Surveyor during periapsis passages through the upper part of the Martian atmosphere, before, during and after a major dust storm.

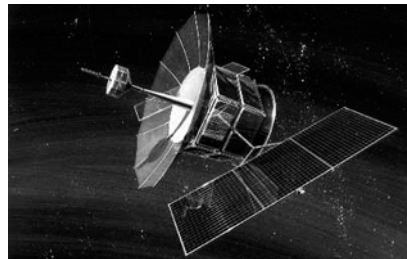
An artist's impression of a FLTSATCOM satellite.

On 6 August 1981 an Atlas–Centaur deployed FLTSATCOM 5, a communications satellite for the US Navy.²⁹ The satellite separated in a ‘blind spot’ over the eastern Atlantic, and was acquired when it came into view of a ground station. As was normal, the telemetry was at first garbled, since the signal was initially weak and the

decoding software had difficulty synchronising with the subcarrier's data. When it *remained* garbled, contingency procedures, including resetting some of the systems, made it readable. The bus voltage and current, and the battery charging current, were fluctuating wildly. The spacecraft was spinning and its thruster temperatures were elevated because they had been firing. However, the attitude dynamics were anomalous, implying that some mechanical damage had changed the moments of inertia. Bypassing the battery-charge regulator and placing the batteries directly onto the bus stabilised the voltages but not the currents. The power engineers concluded that the solar arrays had been damaged, and pinpointed the damage by comparing the telemetry with their wiring diagrams. The satellite was out of immediate danger, but time was of the essence. The low perigee of its transfer orbit caused rapid orbit decay, and each orbit took it twice through the van Allen belts. Before the Star 37F motor could be fired, the satellite had to be spun up from its present rate of 30 revolutions per minute to 60. As this was being done, a nutation suddenly developed at 45 revolutions per minute, and the operation had to be suspended while this unwanted motion was damped out. Once the satellite was spinning at the required rate, the motor had to be aligned for the burn to raise the perigee and reduce the inclination to 2 degrees, but the possibility of mechanical damage meant that the thrust vector might not be aligned with the satellite's spin axis, in which case the offset would sap the motor's performance by a cosine factor. A quick dynamic analysis of the spin telemetry indicated that the motor could be as much as 15 degrees off the spin axis. Hedging on the motor's performance, the controllers aimed for a 7-degree inclination, which the liquid propulsion system would subsequently be able to reduce to 2 degrees. If the misalignment was less than estimated, the burn would produce an orbit with a period in excess of 24 hours, but this too would be correctable. As events transpired, the result was an acceptable 'drift' orbit at 5.4 degrees. At this point, the satellite unfolded its solar arrays without incident, but the two UHF antennas failed to deploy and they resisted efforts to shake them loose. Measurements of the gain pattern of the omni antenna suggested that the UHF-transmit antenna was bent, but in fact the inner lining of the payload shroud had delaminated and struck the satellite. The UHF-receive antenna had broken at its base but remained attached during the initial operations. Only when the spacecraft was spun up to 45 revolutions per minute did it fly off, causing the nutation event. Fortunately, a signals-monitoring aircraft had been able to record telemetry during the 'blind spot', and when this was made available it enabled a variety of failure modes to be simulated. However, despite having been nursed to near-geosynchronous orbit, the satellite had to be written off.³⁰

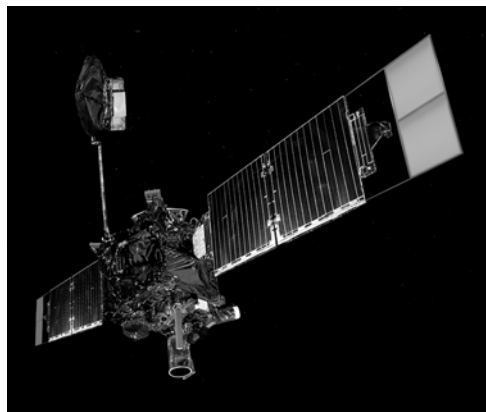
An artist's impression of Mars Global Surveyor with its high-gain antenna deployed.

Global Surveyor spacecraft. The plan was to deploy the 1.5-metre-diameter high-gain antenna on its 2-metre boom immediately after achieving the mapping orbit, but difficulty encountered with a similar mechanism on Earth led to concern that the antenna on the spacecraft might become damaged during the deployment. In its stowed configuration the antenna was held tight against the side of the boxy spacecraft, and for it to be used the spacecraft had to be oriented to point it at the Earth, which required slewing the spacecraft back and forth to point its instruments at the planet and then to downlink the data. In its deployed configuration, the antenna was to rotate to maintain itself pointing at the Earth while the spacecraft maintained its instruments aimed at the planet. After three weeks of deliberation, on 28 March 1999 the antenna was commanded to deploy, which it did successfully. On 15 April, however, the azimuthal gimbal stalled, possibly as a result of a cable or thermal blanket snagging, or perhaps due to either a lubrication problem or a bent or broken gearwheel tooth.³² After analysing the situation, the engineers concluded that the limited mobility of the antenna would facilitate unfettered mapping until February 2000. As the basic mapping mission was to last one year, this activity was able to be completed without significant loss.^{33,34} After that time, the spacecraft had once again to divide its time between taking and transmitting data.

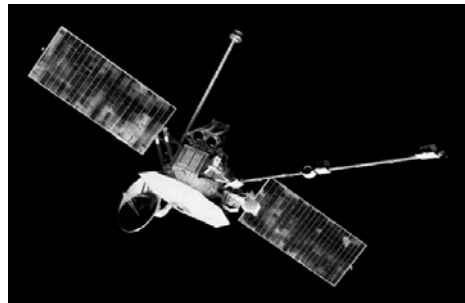
An artist's impression of Mariner 10.

The first (and so far only) spacecraft to visit the planet Mercury almost did not make it. Ironically, since many of the later problems were associated with overheating, one of the first problems was the failure of the heaters for its primary instrument, the television cameras. These heaters were to keep the optics (which obviously could not be pointed at the Sun) at a constant benign temperature. If the optics were to become too cold, thermal contractions might cause their components to become misaligned, unfocused, or even to crack. Despite the fact that the lifetime of the vidicon tubes of the cameras in space was unknown, and had been nominally qualified for only a total of a few weeks of use, it was decided to keep the cameras switched on so as to maintain their operating temperature. In December 1973, a drop by a factor of 4 in the signal output, believed to be due to the thermally induced failure of a joint in the feed for the high-gain antenna, threatened the television plans. Intriguingly, this went through several cycles of failing and repairing itself during the mission. The fact that Mariner 10 had more anomalies than its predecessors may well have been due to the higher thermal loads. On 8 January 1974 the power mysteriously and irreversibly switched to the back-up system. On 28 January, after a gyro malfunction, the attitude control system wasted 16 per cent of its supply of nitrogen propellant. The loss of so much gas so early was of great concern, as it was hoped that Mariner 10 would be able to perform three flybys of Mercury. The Venus flyby in February put the spacecraft on course for Mercury, but the gyro problem ruled out mid-course corrections. Nevertheless, the flyby on 29 March was a success. However, two days later an electrical short drained 90 watts from the power system and made the power electronics bay run very hot, which obliged the engineers to switch off the cameras to relieve the load. Shortly thereafter the tape recorder failed, which meant that future flyby data would have to be downloaded

in real-time, presuming that the high-gain antenna held out. To make matters worse, part of the telemetry system was also lost. At one point, the scan platform on which the cameras were mounted threatened to fail. Despite these issues, the second flyby of Mercury was accomplished on 21 September. The gyro problems were compounded on 6 October by a bright particle nearby that caused the star tracker to lose its lock on the Canopus reference star. Because the gas supply was by this point perilously low, the engineers decided to tilt the solar panels in order to use solar radiation pressure (i.e. 'solar sailing') to help to control the attitude of the spacecraft. The failure of the cooler of the radio receiver at the Deep Space Communications Complex at Canberra in Australia, the only site with a clear line of sight to the spacecraft for the final flyby on 16 March 1975, resulted in the loss of much of the data. (This cooler kept the receiver noise down, and the unbuffered telemetry from the television cameras at the maximum data rate became unacceptably noisy.) A partial recovery was effected by sending only the central part of each image at one-fifth speed to yield a tolerably low error rate.^{60,61,62} The attitude control system ran dry one week later. Overall, the mission was a great success, squeezing a vast scientific return from a modest spacecraft, in part by pushing the bandwidth to an unprecedented 117,600 bits per second (a decade earlier, Mariner 4 had transmitted its pictures of Mars at a mere 8 bits per second) and in part by exploiting a resonant orbit to set up three flybys of Mercury. The stress on the operations teams in nursing the ailing spacecraft along to yield a total of 2,400 useful pictures of Mercury and 3,400 of Venus was nevertheless severe.

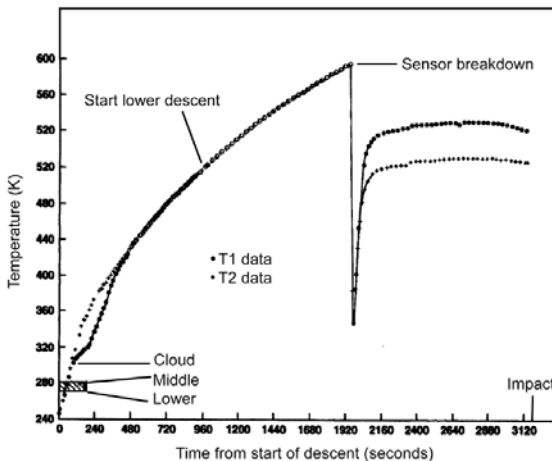
The temperature profile measured by the 'Northern' Pioneer Venus probe during its descent through the Venusian atmosphere.

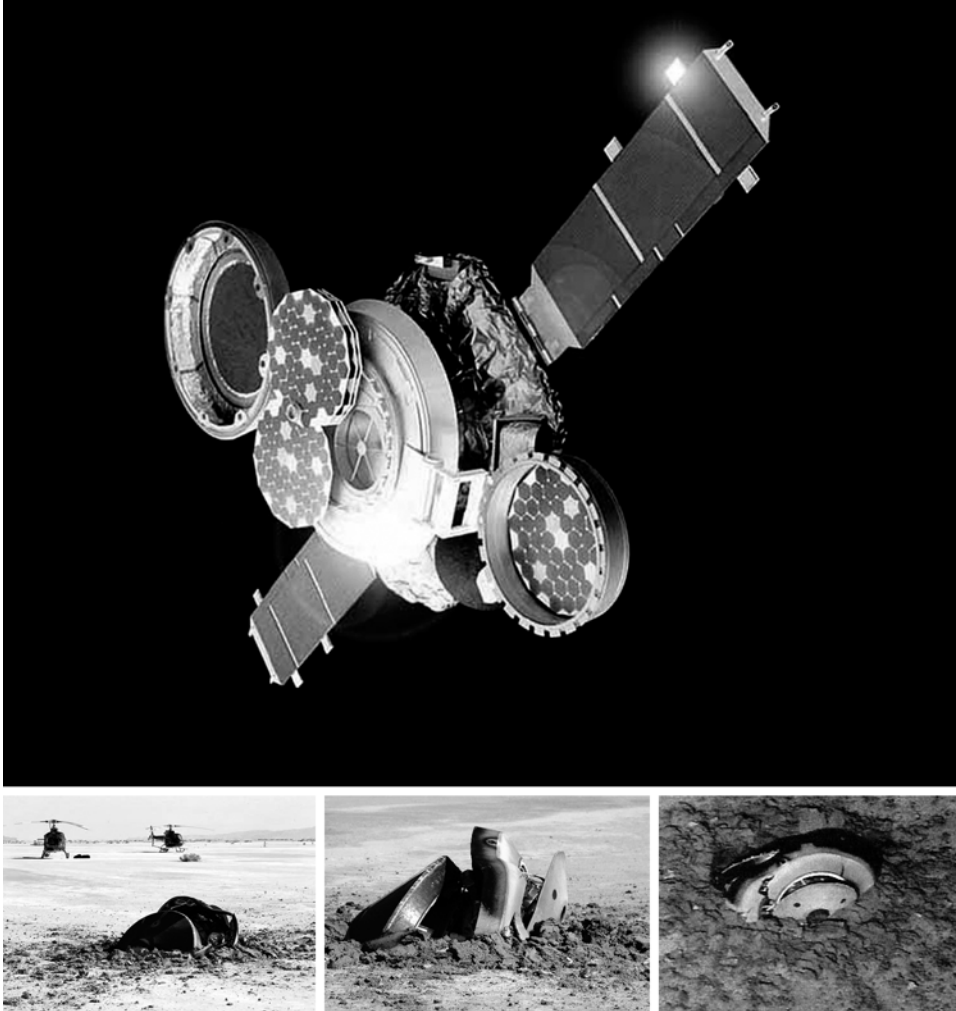
An artist's impression of the Genesis spacecraft with its sample collectors exposed. On returning to Earth, the capsule failed to deploy its parachute and embedded itself in the ground (bottom).

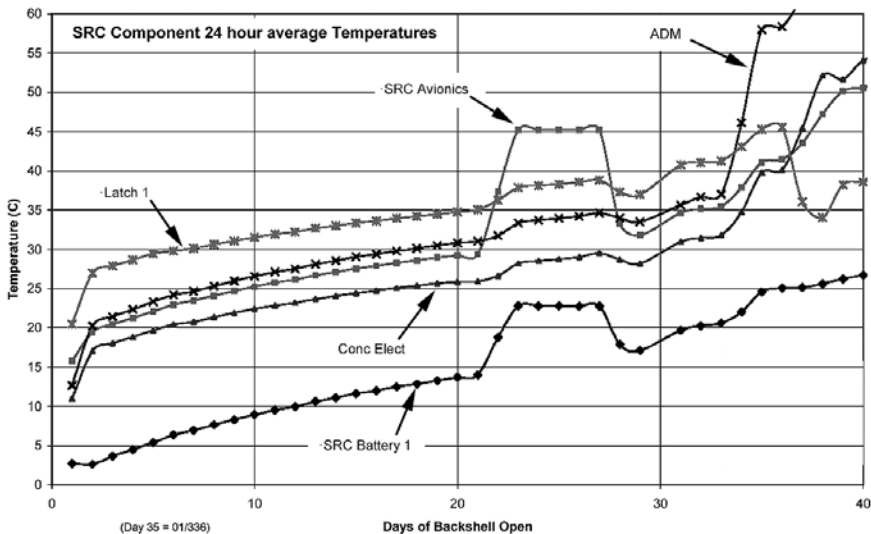
A plot of the temperature variations of the Sample Return Capsule (SRC) of the Genesis spacecraft showing the temporary anomalous heating of its battery and avionics.

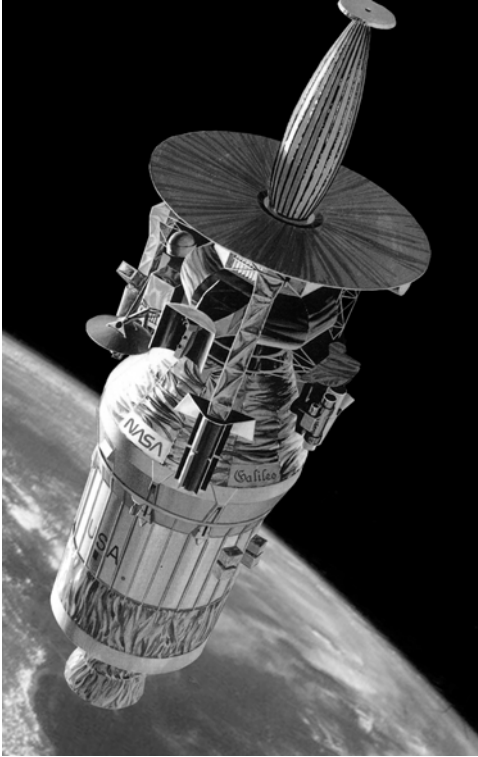
An artist's impression of an IUS with the Galileo spacecraft, its high-gain antenna in its stowed configuration.

One celebrated – if that is the appropriate word – example of ground-handling failure is the high-gain antenna of the Galileo spacecraft: when commanded to deploy on 11 April 1991 it jammed. An Anomaly Team was established by JPL, drawing upon mechanical, electrical, thermal, and materials specialists, as well as staff from the Harris Corporation, which had built the 4.8-metre-diameter umbrella structure using the same design as the antennas of the Tracking and Data Relay

indicating that at least some of the pins had failed to release. Another clue was that Galileo had assumed a slight wobble, which implied that the antenna was partially deployed in an asymmetrical state. Finally, in certain orientations, a Sun sensor's field of view was masked by one of the ribs of the antenna. In all likelihood, several ribs had jammed as a result of etching of their surfaces once excessive friction between the stand-off pins and sockets had eroded the molybdenum disulphide dry lubricant. The cause was vibration experienced on repeated cross-country trips: after man-

Satellites. The deployment sequence called for an electric motor to release the pins that held the 18 graphite-epoxy ribs of the structure alongside the central support tower. The ribs were to draw a thin molybdenum mesh into a parabolic dish. The pin release motor was immediately beneath a small circular shield that had been installed on the tip of the tower to protect the antenna's structure from the Sun while the spacecraft was inside the Earth's orbit. It was clear that this command had been received and that the mechanism had been activated, because the motor had drawn an electrical current. However, telemetry showed that the motor had operated at a higher power than expected, indicating that it had encountered an unexpected frictional force. Another anomaly was the microswitch that was to have deactivated the motor after a few seconds, by which time the pins ought to have released, did not trigger,

ufacture in Florida the antenna had been driven over to JPL by truck in a special container; in 1985 it was taken to the Kennedy Space Center for integration and launch; on the loss of Challenger and the cancellation of the Centaur deployment stage in 1986 the spacecraft was driven to JPL for modification and returned to Florida in 1989. Extensive analysis determined that the problem existed at launch and went undetected. It was not related to the revision of the flight plan to include flybys of Venus, which required that the tip shield be added, nor to the consequent delay in the deployment of the antenna until the spacecraft was beyond the Earth's orbit and in the environment for which it had been designed.^{15,16}

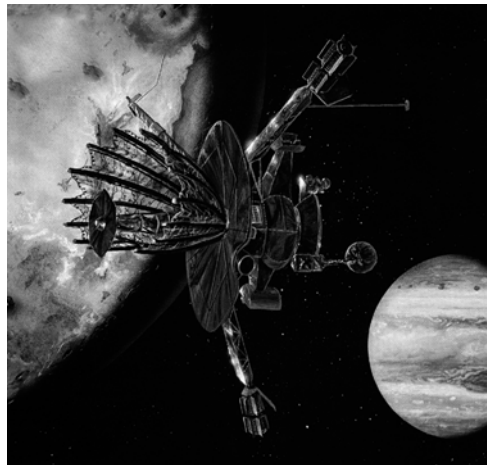
An artist's impression of the Galileo spacecraft in the Jovian system with its partially deployed high-gain antenna.
